IMAGES IN INTERVENTION

Early Collapse of a Magnesium Bioresorbable Scaffold

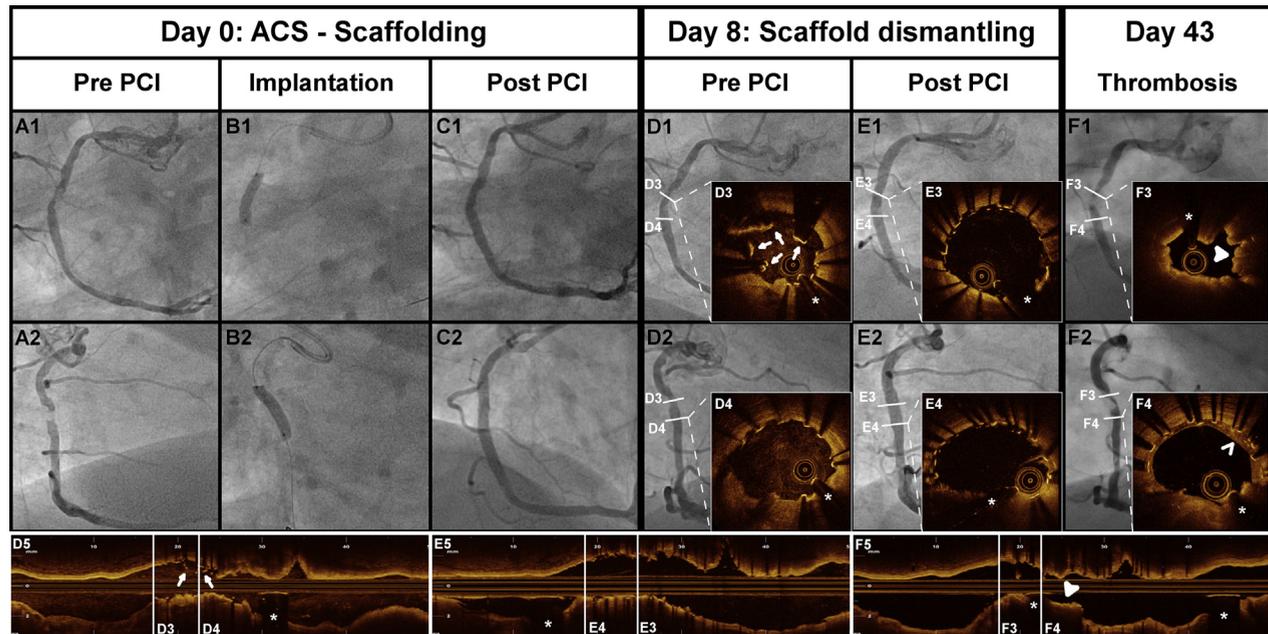
FIGURE 1 Angiography and OCT Images at Index, 8 Days, and 43 Days

Elective percutaneous coronary intervention of the mid-left anterior descending artery was planned 8 days later. However, coronary angiography showed focal BRS collapse with substantial loss of the lumen dimensions (Figures 1D1 and 1D2). Optical coherence tomography (OCT) confirmed scaffold dismantling

(Figures 1D3 to 1D5). A 3.5 × 23.0-mm cobalt chromium everolimus-eluting stent (Abbott Vascular, Santa Clara, California) was then deployed with excellent angiographic (Figures 1E1 and 1E2) and OCT result (Figures 1E3 to 1E5).

One month later, the patient presented with non-ST-segment elevation acute coronary syndrome. Coronary angiography showed late stent thrombosis with preserved Thrombolysis In Myocardial Infarction flow (Figures 1F1 and 1F2). OCT at the overlapped segment showed intraluminal thrombus, uncovered struts, and heterogeneous neointimal tissue (Figures 1F3 to 1F5). Thrombus-aspiration and dilatation with a 4 × 15-mm noncompliant balloon were then performed with good result. However, 6 weeks later, an elective coronary angiography showed severe in-stent restenosis, and the patient was referred for surgical revascularization.

This is the first description to our knowledge of premature dismantling and loss of radial force of

(A1 and A2) Initial angiography. (B1 and B2) Optimal expansion of the scaffold delivery balloon. (C1 and C2) Final angiographic result after magnesium bioresorbable scaffold implantation. (D1 and D2) Angiography 8 days after implantation. White lines indicate locations of optical coherence tomography (OCT) images. (D3 and D5) OCT revealing scaffold dismantling (arrows). (D4) Well-apposed scaffold with minor distal edge dissection. (E1 to E5) Angiography and OCT after cobalt chromium everolimus-eluting stent implantation. (F1 and F2) Angiography 43 days later. (F3 and F5) OCT revealing intraluminal thrombus (filled arrowheads) and (F4) heterogeneous neointimal tissue (open arrowhead). The asterisk represents the wire artefact. ACS = acute coronary syndrome; PCI = percutaneous coronary intervention.

the current magnesium BRS. Strut corrosion is an exclusive phenomenon of magnesium BRS. Strut corrosion rate may vary between different individuals, and may be accelerated by scaffold malapposition, focal low pH between vessel wall and BRS struts and also by substantial hinging forces. Further investigation is warranted to recognize the frequency and mechanisms of this early failure.
