IMAGES IN INTERVENTION

Endovascular Repair of Ruptured Pseudoaneurysm of Left Internal Mammary Graft Following Redo Aortic Valve Replacement and Coronary Artery Bypass Grafting

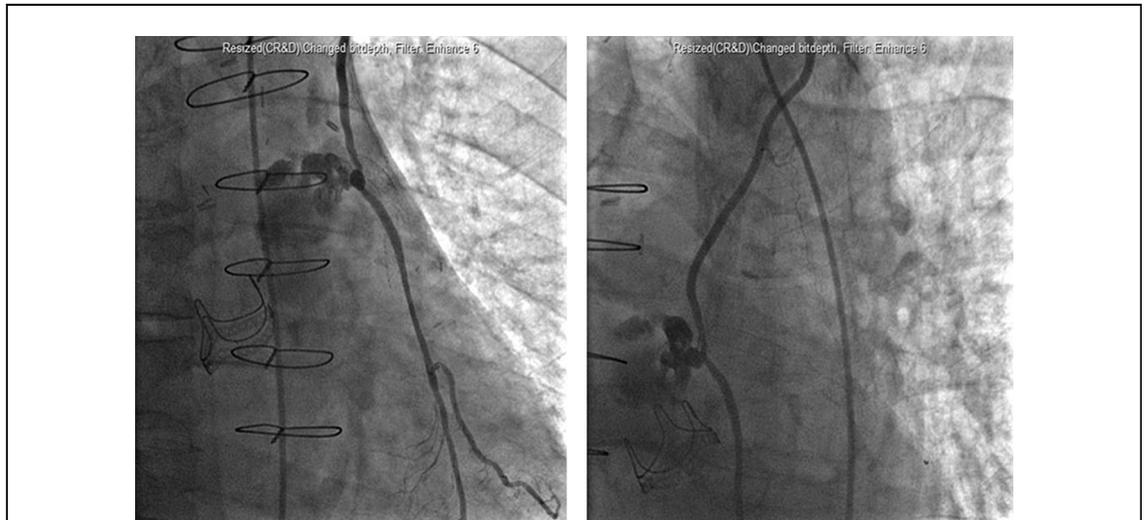
FIGURE 1 Right Anterior Oblique and Left Anterior Oblique Views, Respectively, by Coronary Angiography

These views demonstrate a large (1 cm × 1 cm) pseudoaneurysm in the mid-section of the left internal mammary artery graft with associated rupture as suggested by contrast leakage into the mediastinum ([Online Video 1](#)). The **left panel** shows the right anterior oblique view, and the **right panel** shows the left anterior oblique view.

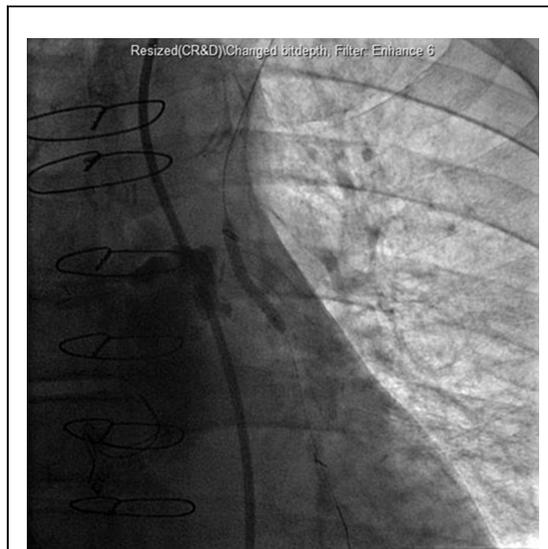
FIGURE 2 Covered Stent (Jostent) Placement at the Site of the Ruptured Pseudoaneurysm in the LIMA Graft

By the femoral arterial route, a 7-F left internal mammary artery (LIMA) guide was used to wire the LIMA. A 3.0 × 26-mm covered Jostent stent (Jomed International AB, Helsingborg, Sweden) was placed at the site of the rupture and inflated to 19 atm pressure ([Online Video 2](#)).

A 62-year-old man status post-coronary artery bypass grafting and aortic mechanical valve replacement presented a decade later with angina and dyspnea. He was found to have a partially thrombosed aortic prosthetic valve. The patient underwent a reoperation with aortic bioprosthetic valve replacement. Two weeks later, the patient was readmitted with acute chest pain and ST-T changes on the electrocardiogram. Urgent coronary angiography showed the previously placed coronary artery grafts to be patent. However, there was a large (1 cm × 1 cm) pseudoaneurysm of the left internal mammary artery (LIMA) graft with leakage of contrast into the mediastinum at the site of the pseudoaneurysm suggesting an associated rupture ([Figure 1](#), [Online Video 1](#)). Utilizing the femoral arterial approach, a 7-F LIMA guide was used to wire the LIMA, and a 3.0 × 26-mm covered Jostent stent graft (Jomed International AB, Helsingborg, Sweden) was placed and inflated to 19 atm. This completely sealed the ruptured pseudoaneurysm, and post-dilation was done with a 3.0 Quantum balloon to 20 atm ([Figure 2](#), [Online Video 2](#)).

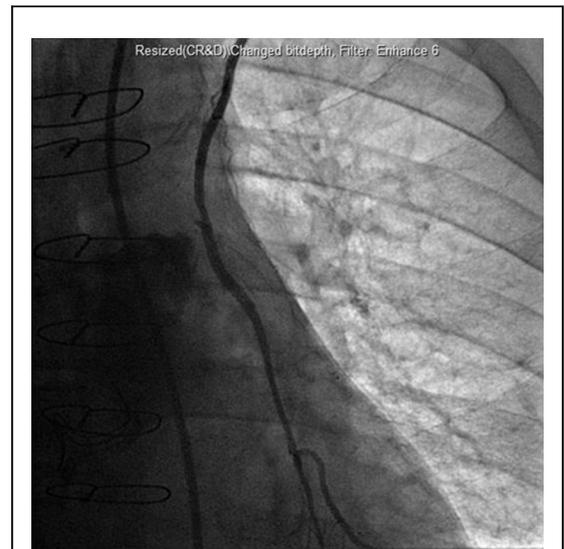
FIGURE 3 Post-Stent LIMA Graft With Good Distal TIMI Flow

Thrombolysis In Myocardial Infarction (TIMI) flow grade III was obtained distally after placement of covered stent (Jostent) at the site of the ruptured left internal mammary artery (LIMA) graft pseudoaneurysm ([Online Video 3](#)). The associated rupture is completely sealed off as evidenced by lack of contrast extravasation.

An excellent result was obtained, with Thrombolysis In Myocardial Infarction flow grade III distally. There was good flow down to the left anterior descending coronary artery (LAD) with some evidence of wire spasm, which improved with intracoronary nitroglycerine. The LAD diagonal, as well as the collaterals to the right coronary artery, was patent. Multiple angiographic views were taken that showed no evidence of further extravasation of contrast ([Figure 3](#), [Online Video 3](#)). The patient was eventually discharged home on dual antiplatelet therapy (aspirin and clopidogrel).
