In-Stent Dissection Causes No Flow During Percutaneous Coronary Intervention

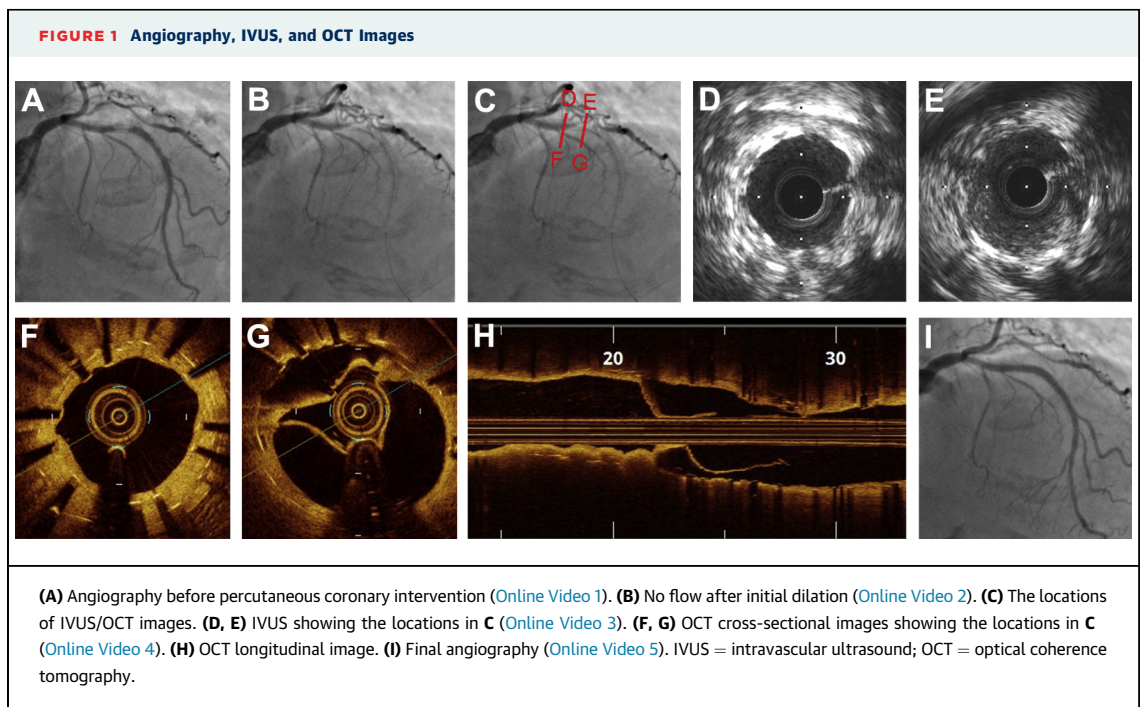
A 71-year-old woman with chest pain consulted us 1 week after an emergent operation for a small intestine perforation. She had previously undergone percutaneous coronary intervention (PCI) twice for the left anterior descending artery. The first was performed with a bare-metal stent 5 years earlier, and the second was performed for in-stent restenosis (ISR) treated with a biolimus A9-eluting stent. Angiography revealed 99% restenosis at the same location as that of the previous ISR (**Figure 1A**, [Online Video 1](#)); therefore, PCI was performed. Immediately after initial dilation using a

semicompliant 2.0-mm balloon, the coronary flow abruptly disappeared (**Figure 1B**, [Online Video 2](#)). The slow-flow/no-reflow phenomenon is associated with myocardial injury, less favorable clinical outcomes, and generally with microthromboemboli. Despite standard treatments such as manual thrombus aspiration and intracoronary vasodilator administration, we could not reestablish coronary flow. To determine the mechanism underlying the no flow, we performed intravascular ultrasound (IVUS), which did not reveal the cause of the no flow (**Figures 1D and 1E**, [Online Video 3](#)). We then

performed optical coherence tomography, which clearly showed a dissection within the previous stent (Figures 1F to 1H, Online Video 4). Subsequent dilation by a cutting balloon re-established coronary flow (Figure 1I, Online Video 5). We speculated that neoatherosclerosis within the stent caused the restenosis, and the initial dilation induced a dissection that caused occlusion and resulted in no flow. This report is the first to show that in-stent dissection can cause no flow during PCI and that optical coherence tomography would uncover the mechanism.
